**Subsidence Documentation Study**  
**Sufco Mine**  
**May 30, 2003**  
**Summary**

The data contained in this binder is a compilation of subsidence features gathered in the field from the 19 of May to the 22 of May 2003. The features have been organized into five different sections representing panels in descending order starting with the most recent. At the beginning of each section is a summary sheet outlining important aspects of the panel with emphasis on subsidence features contained therein.

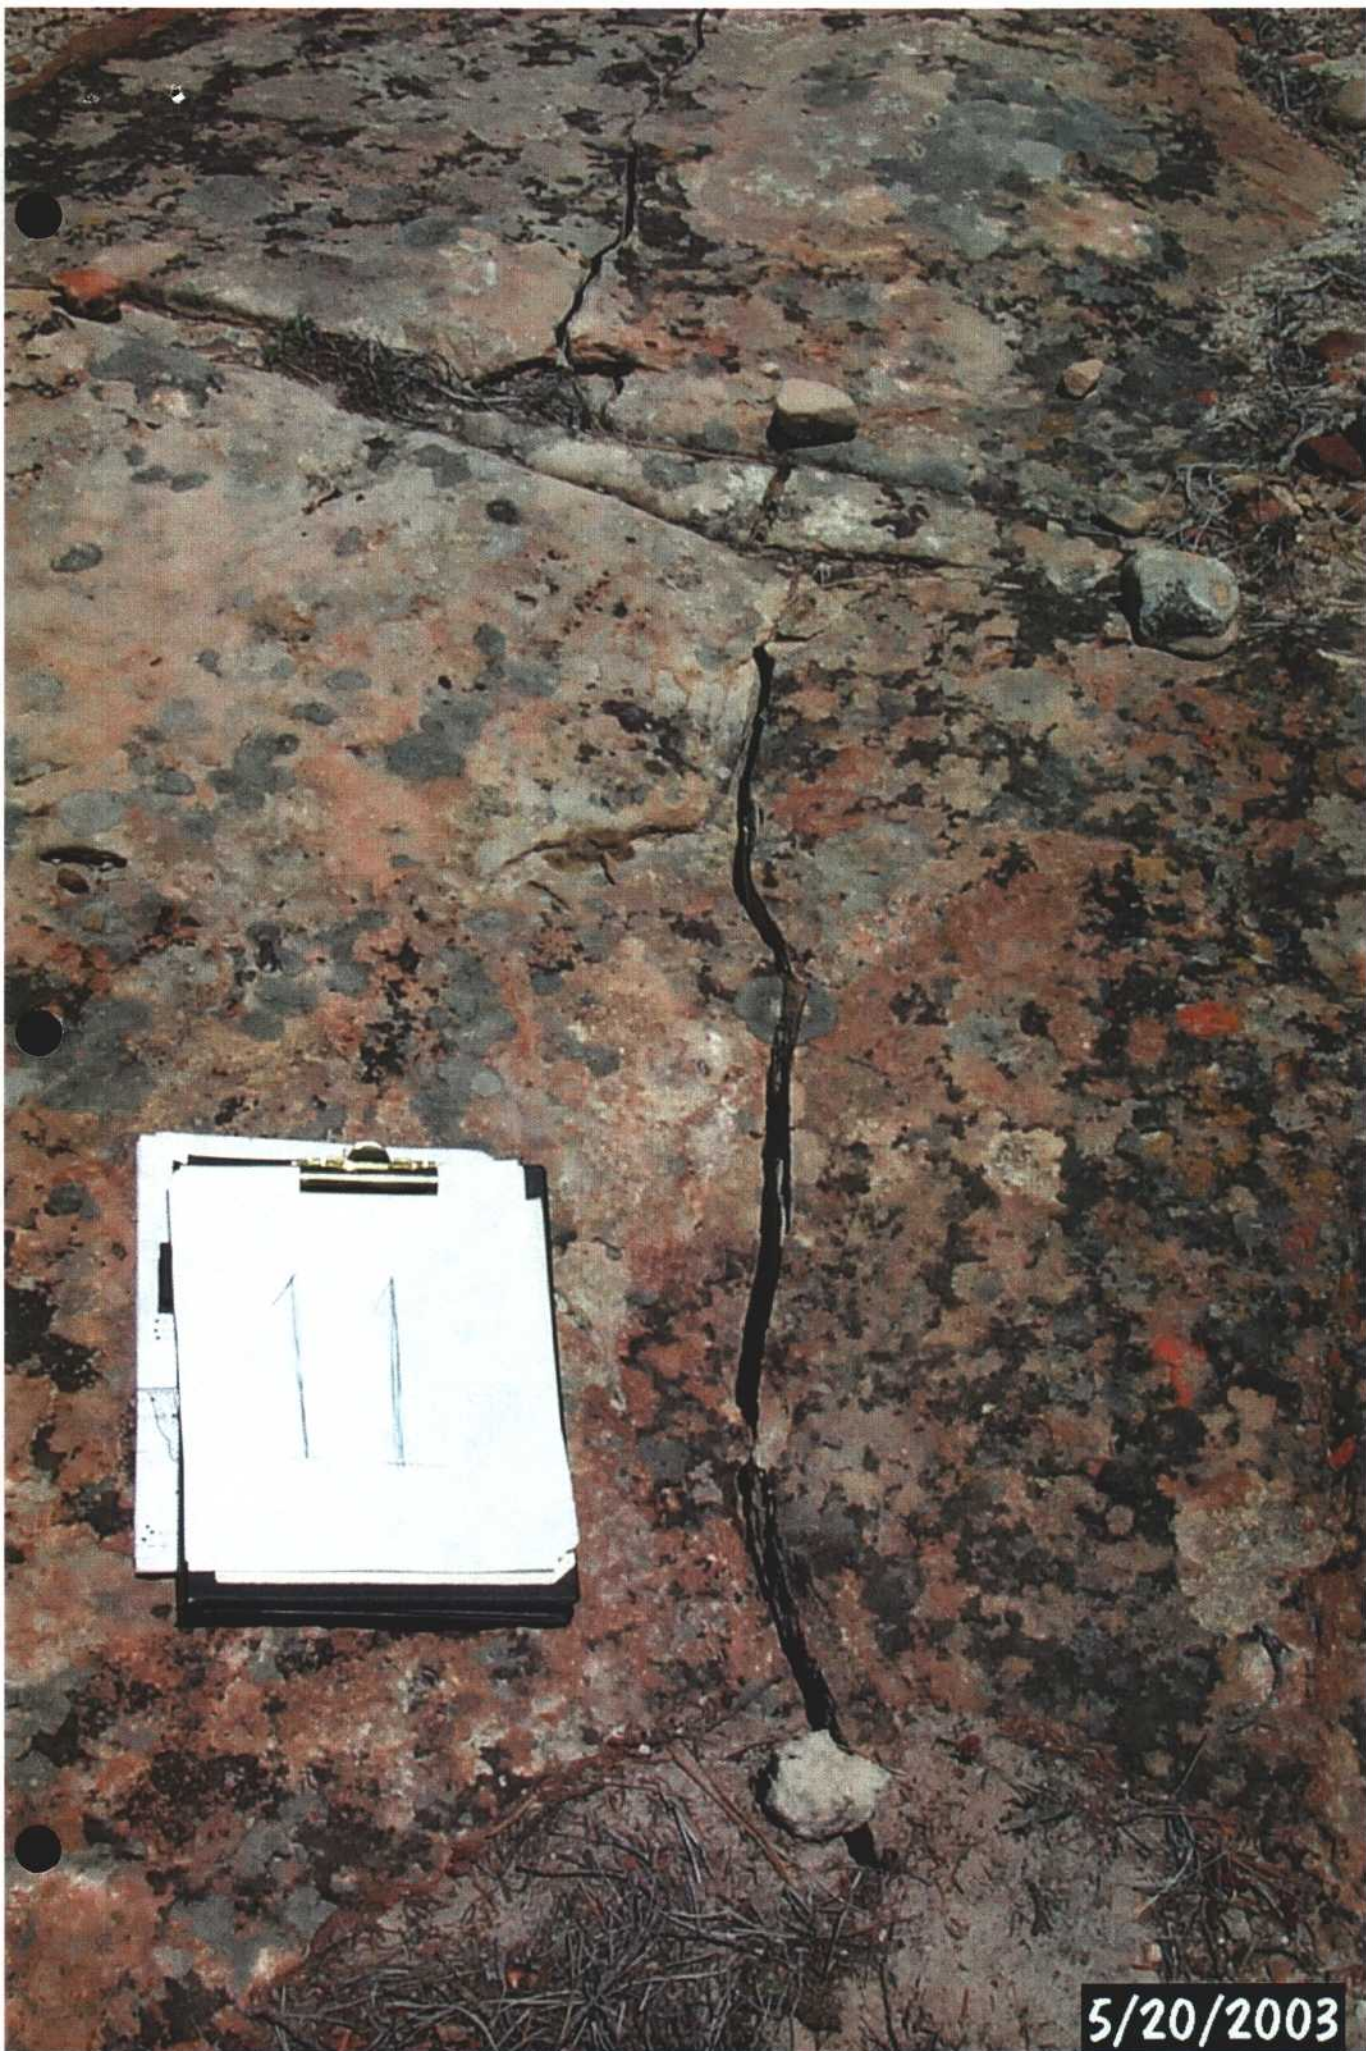
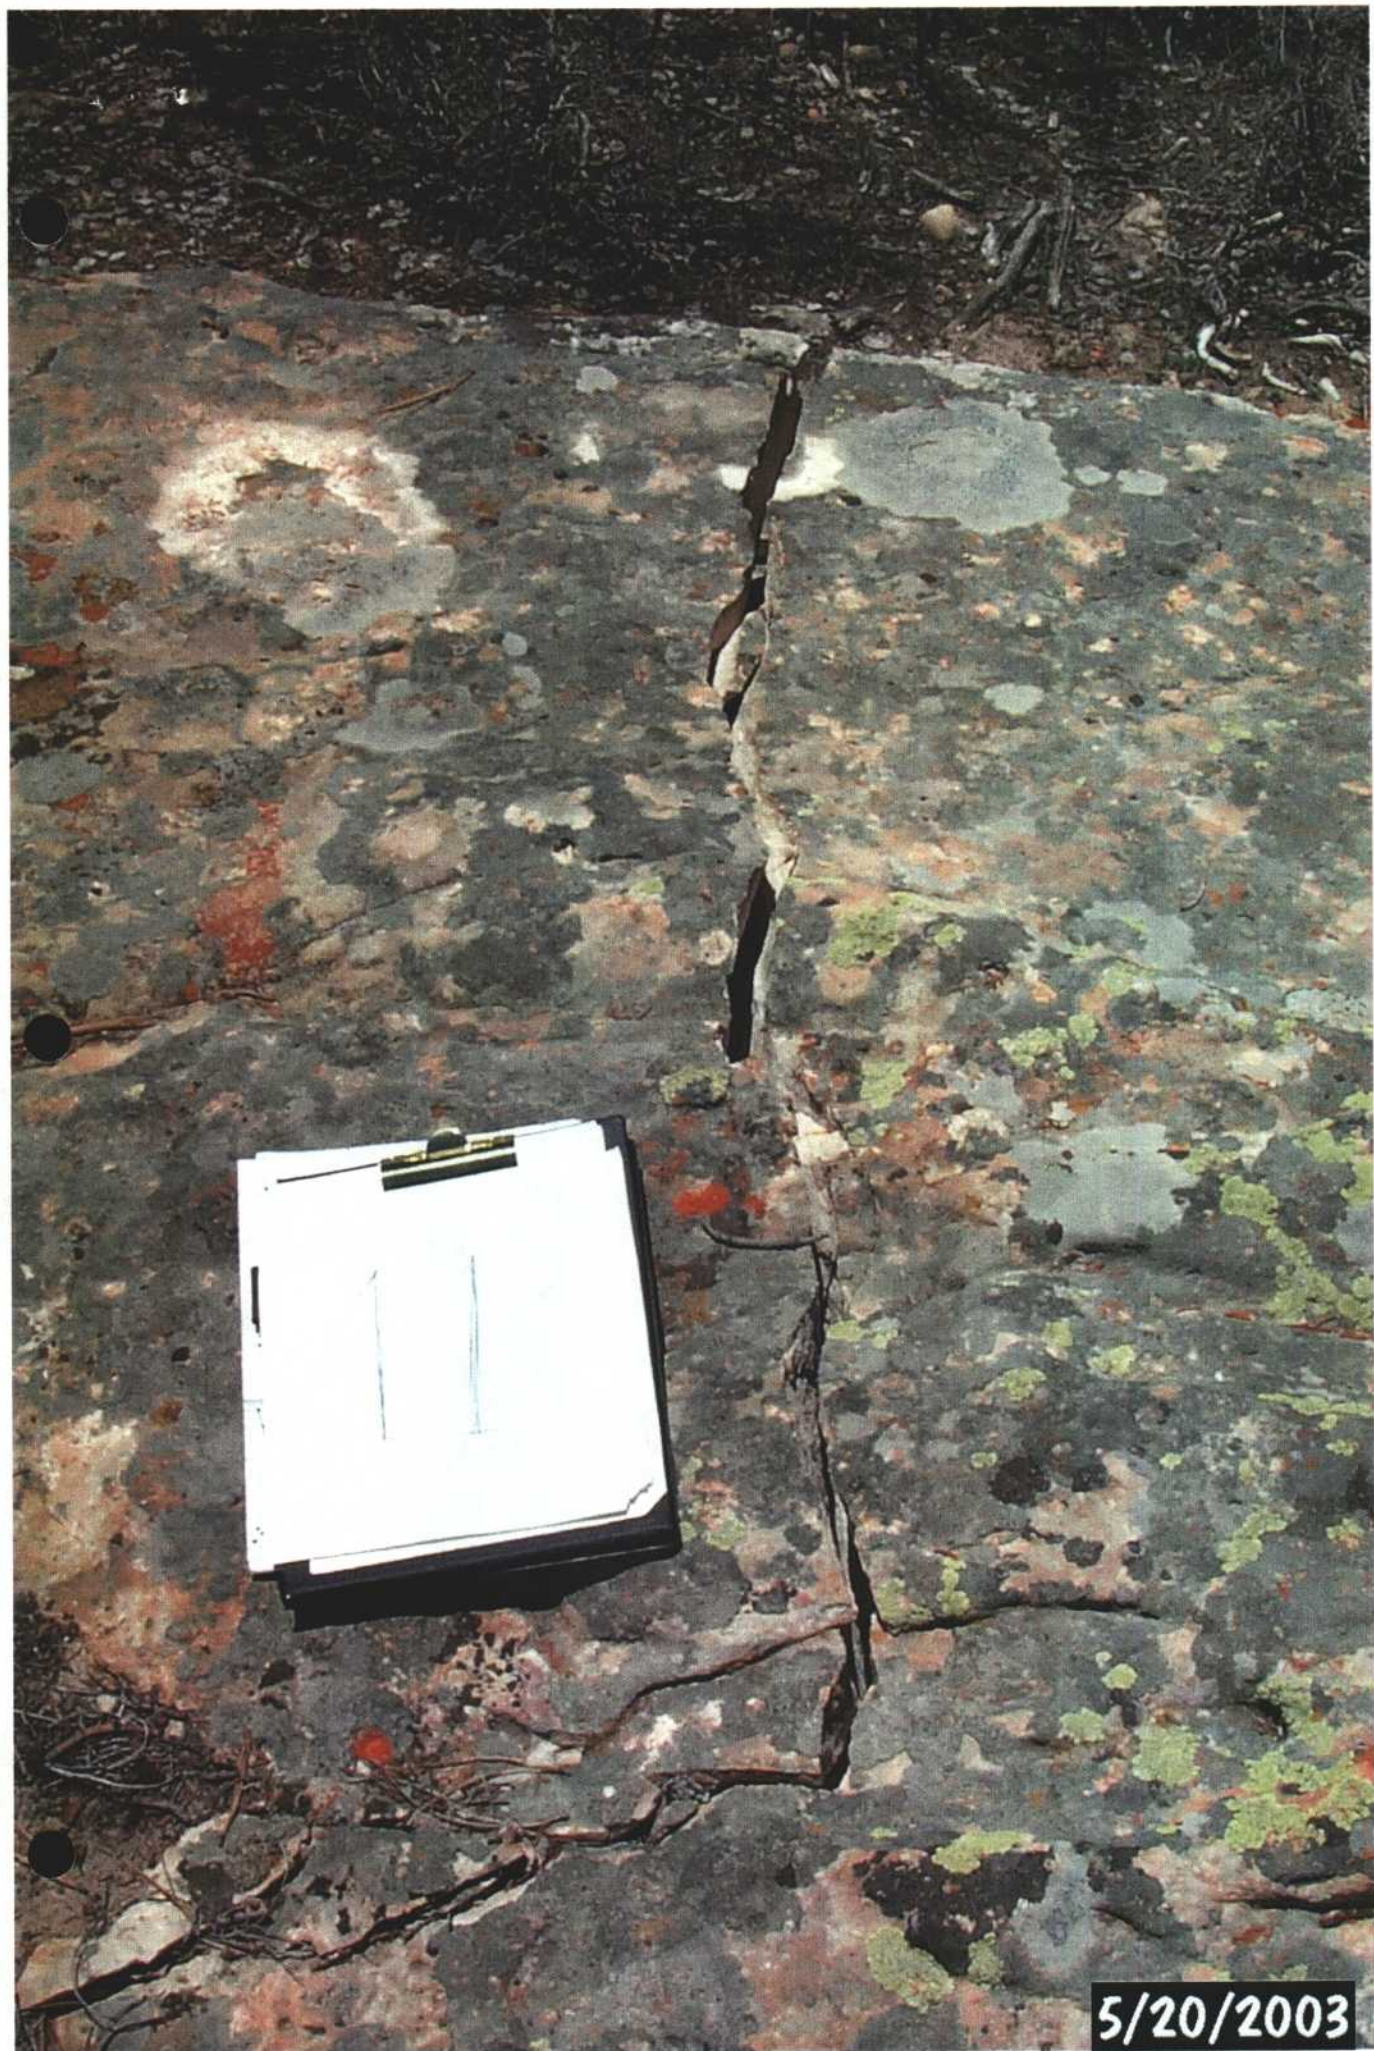
Dimensions (in feet): This crack is approximately 15 feet long, and approximately 2 inches wide.

Potential Hazards? Not really. The remaining overhang could collapse at any time, possibly endangering whatever unfortunate treasure-seeker that happens to be inside at the time.

Other Comments (seeps, stream channel, archeological, eagle nest) and Recommendations (needs work, healing, leave alone watch?):  
These cracks occur directly above the Big Mac Indian Shelter.

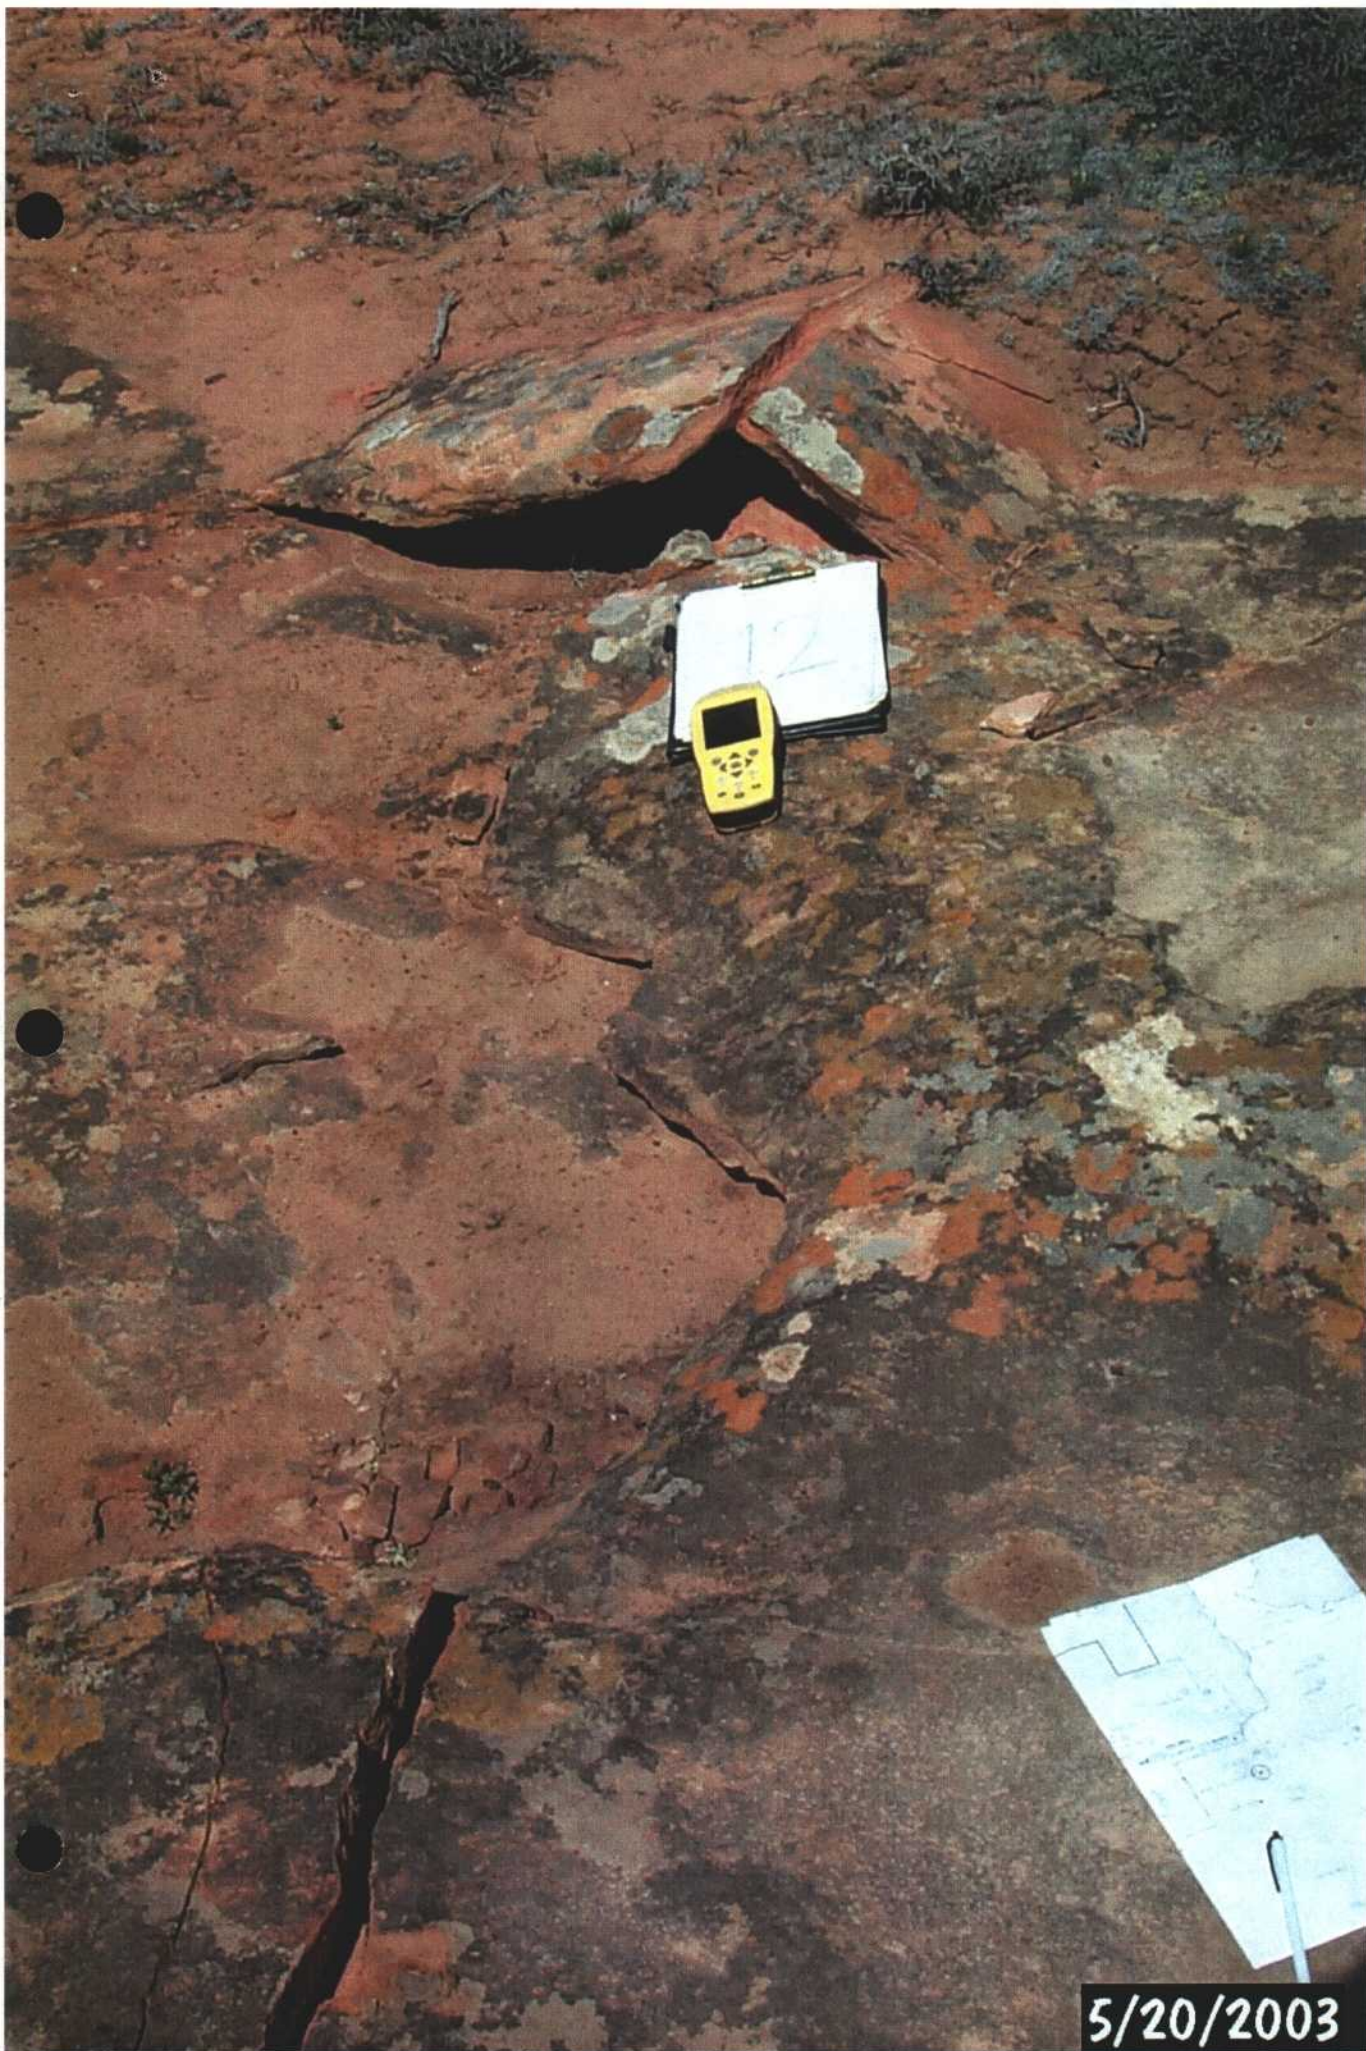
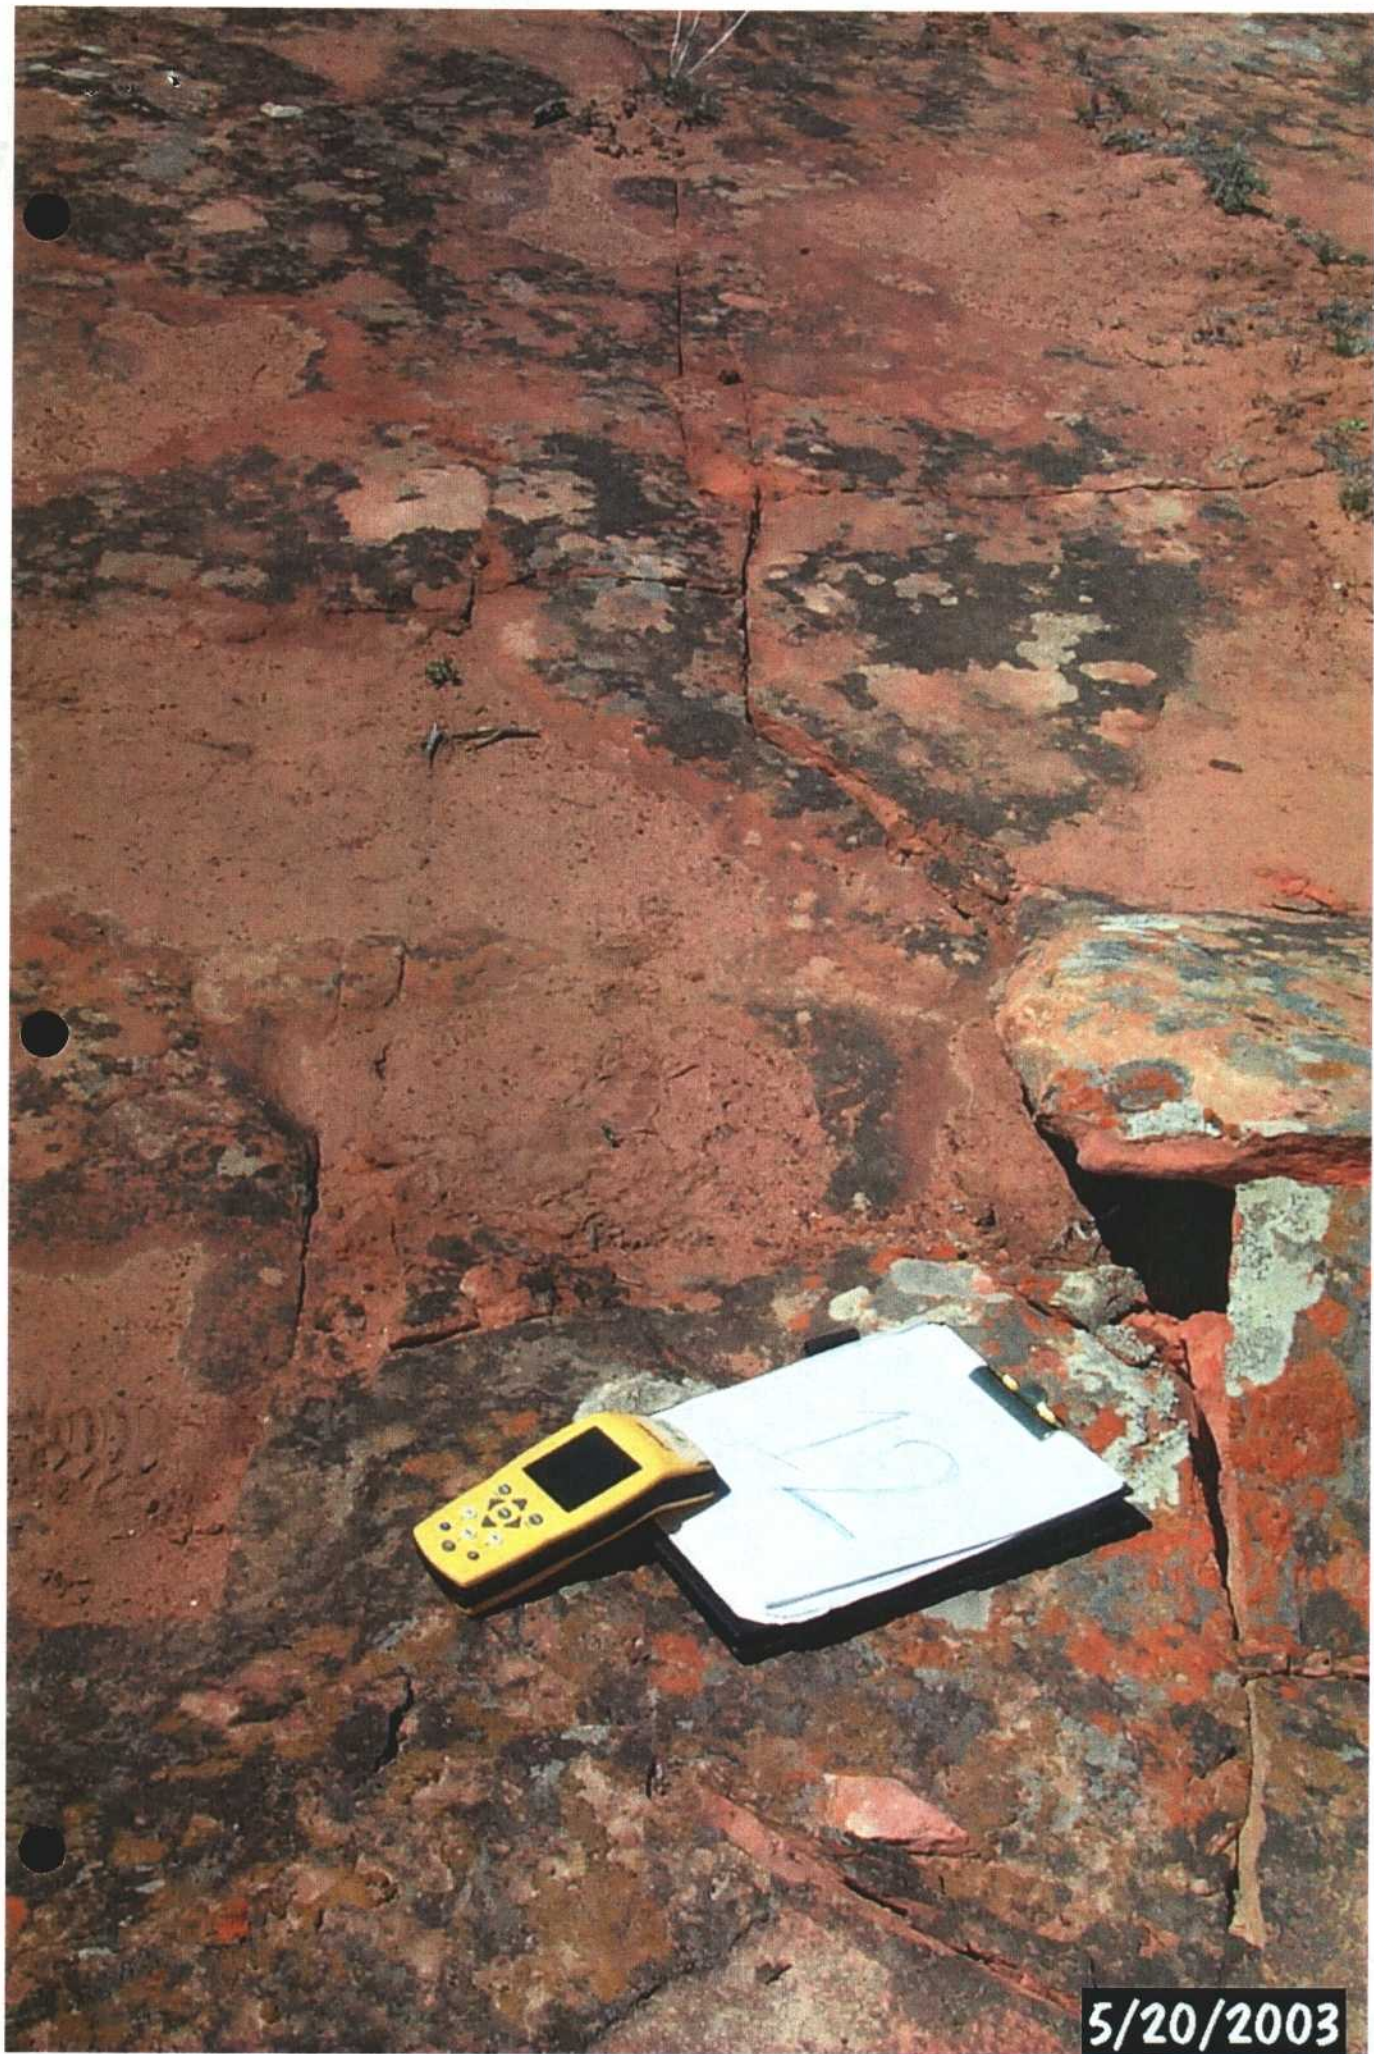
Dimensions (in feet): This crack is 20 feet long, and approximately 2 inches wide.

Cracks are filling in.

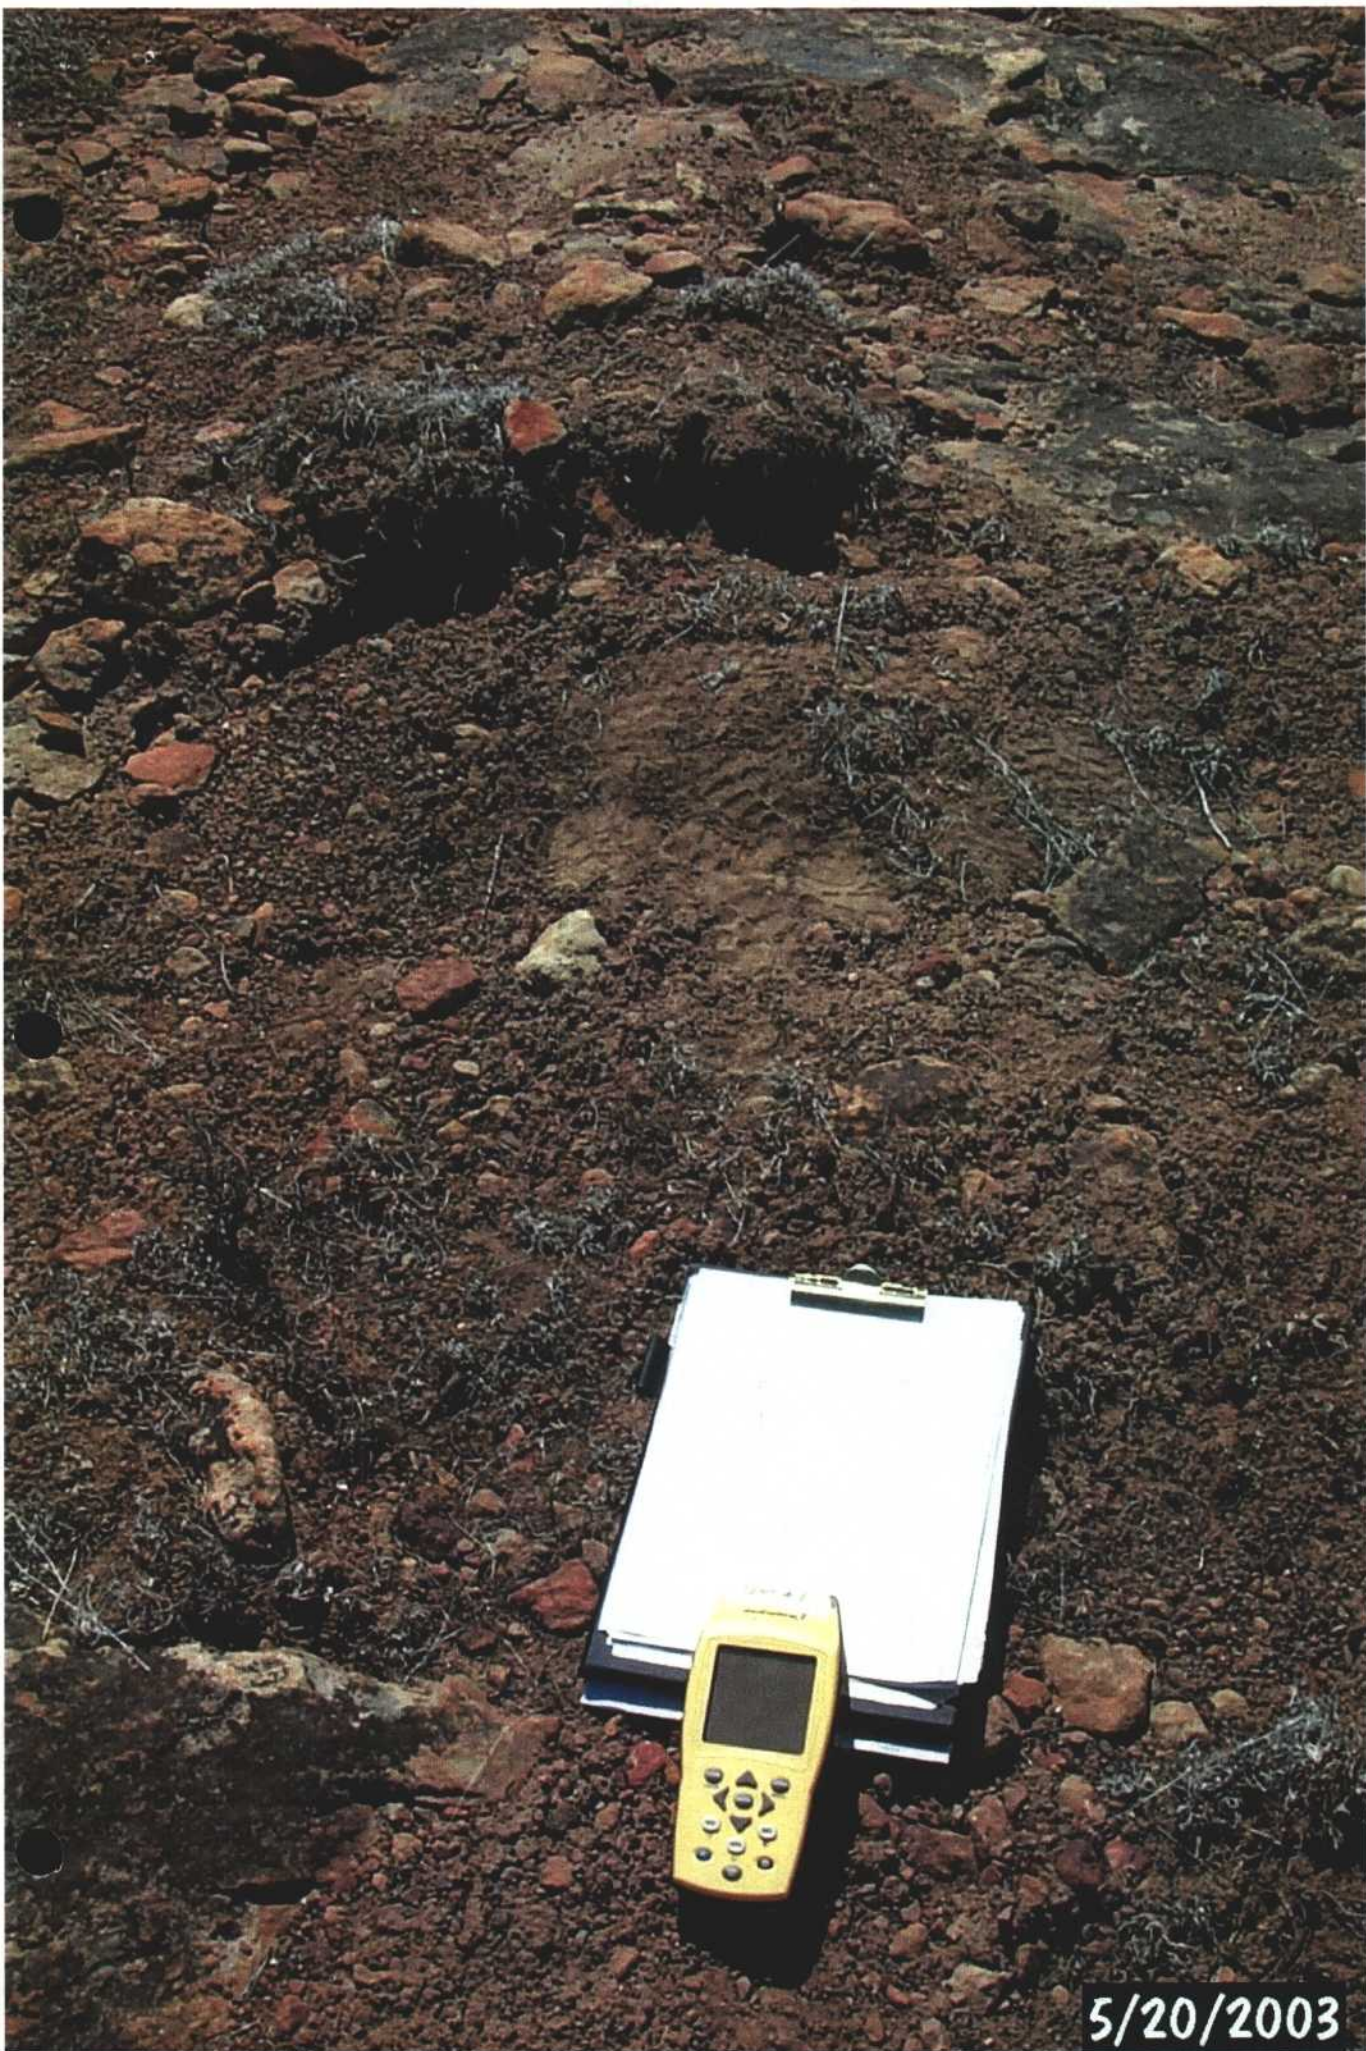
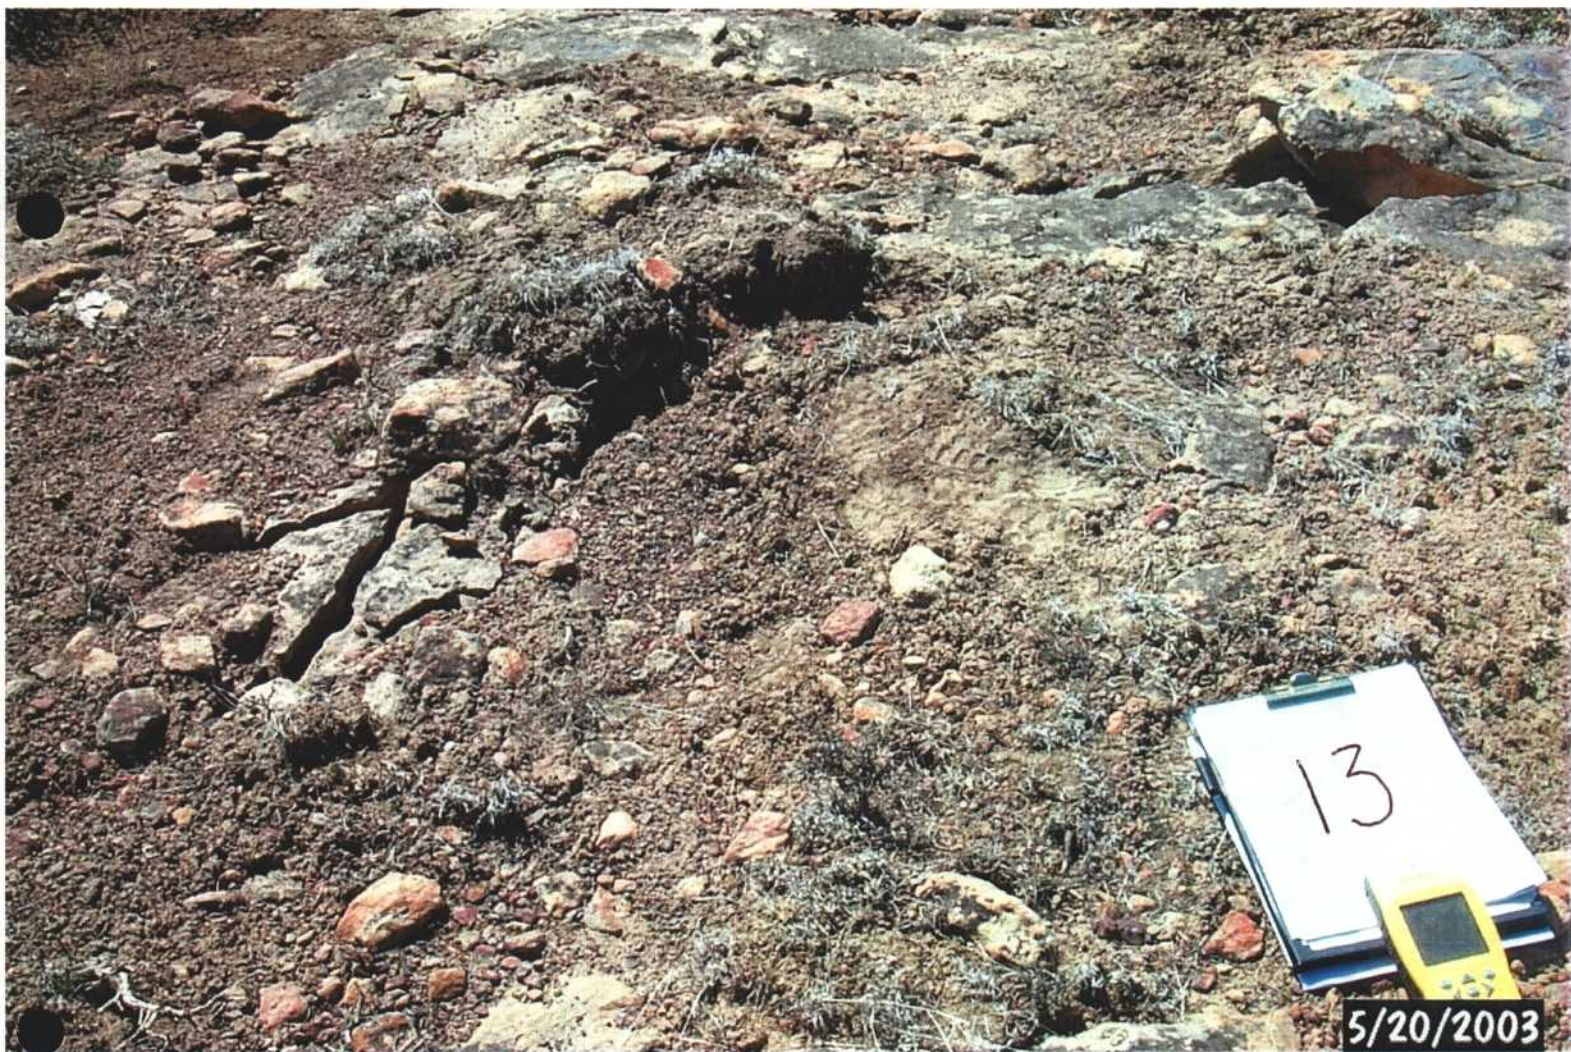
This feature is located just above the Little Mac Indian shelter.

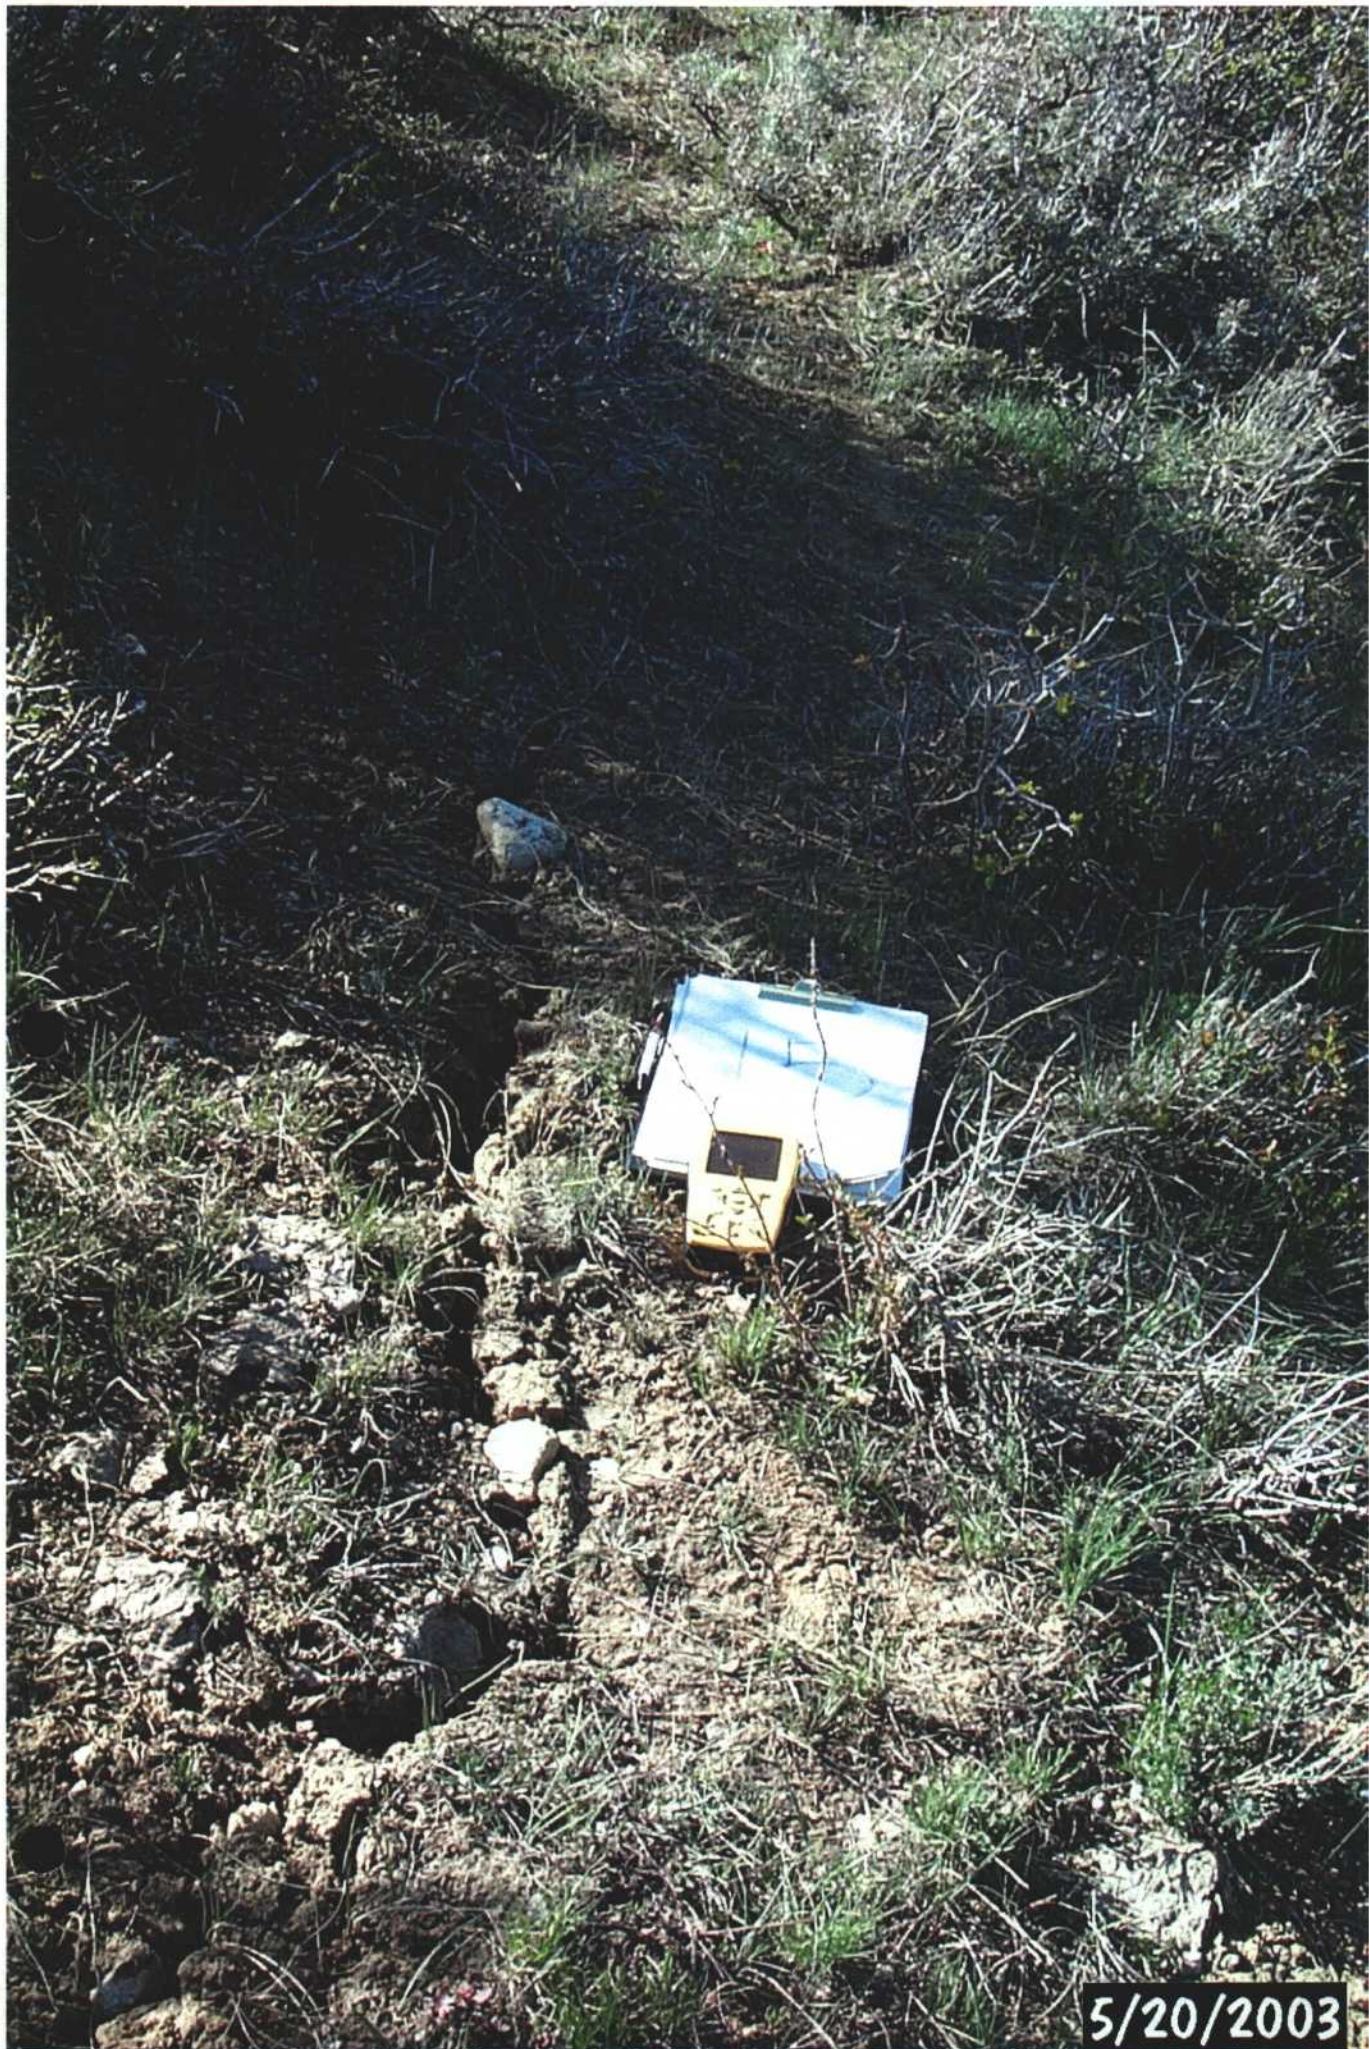
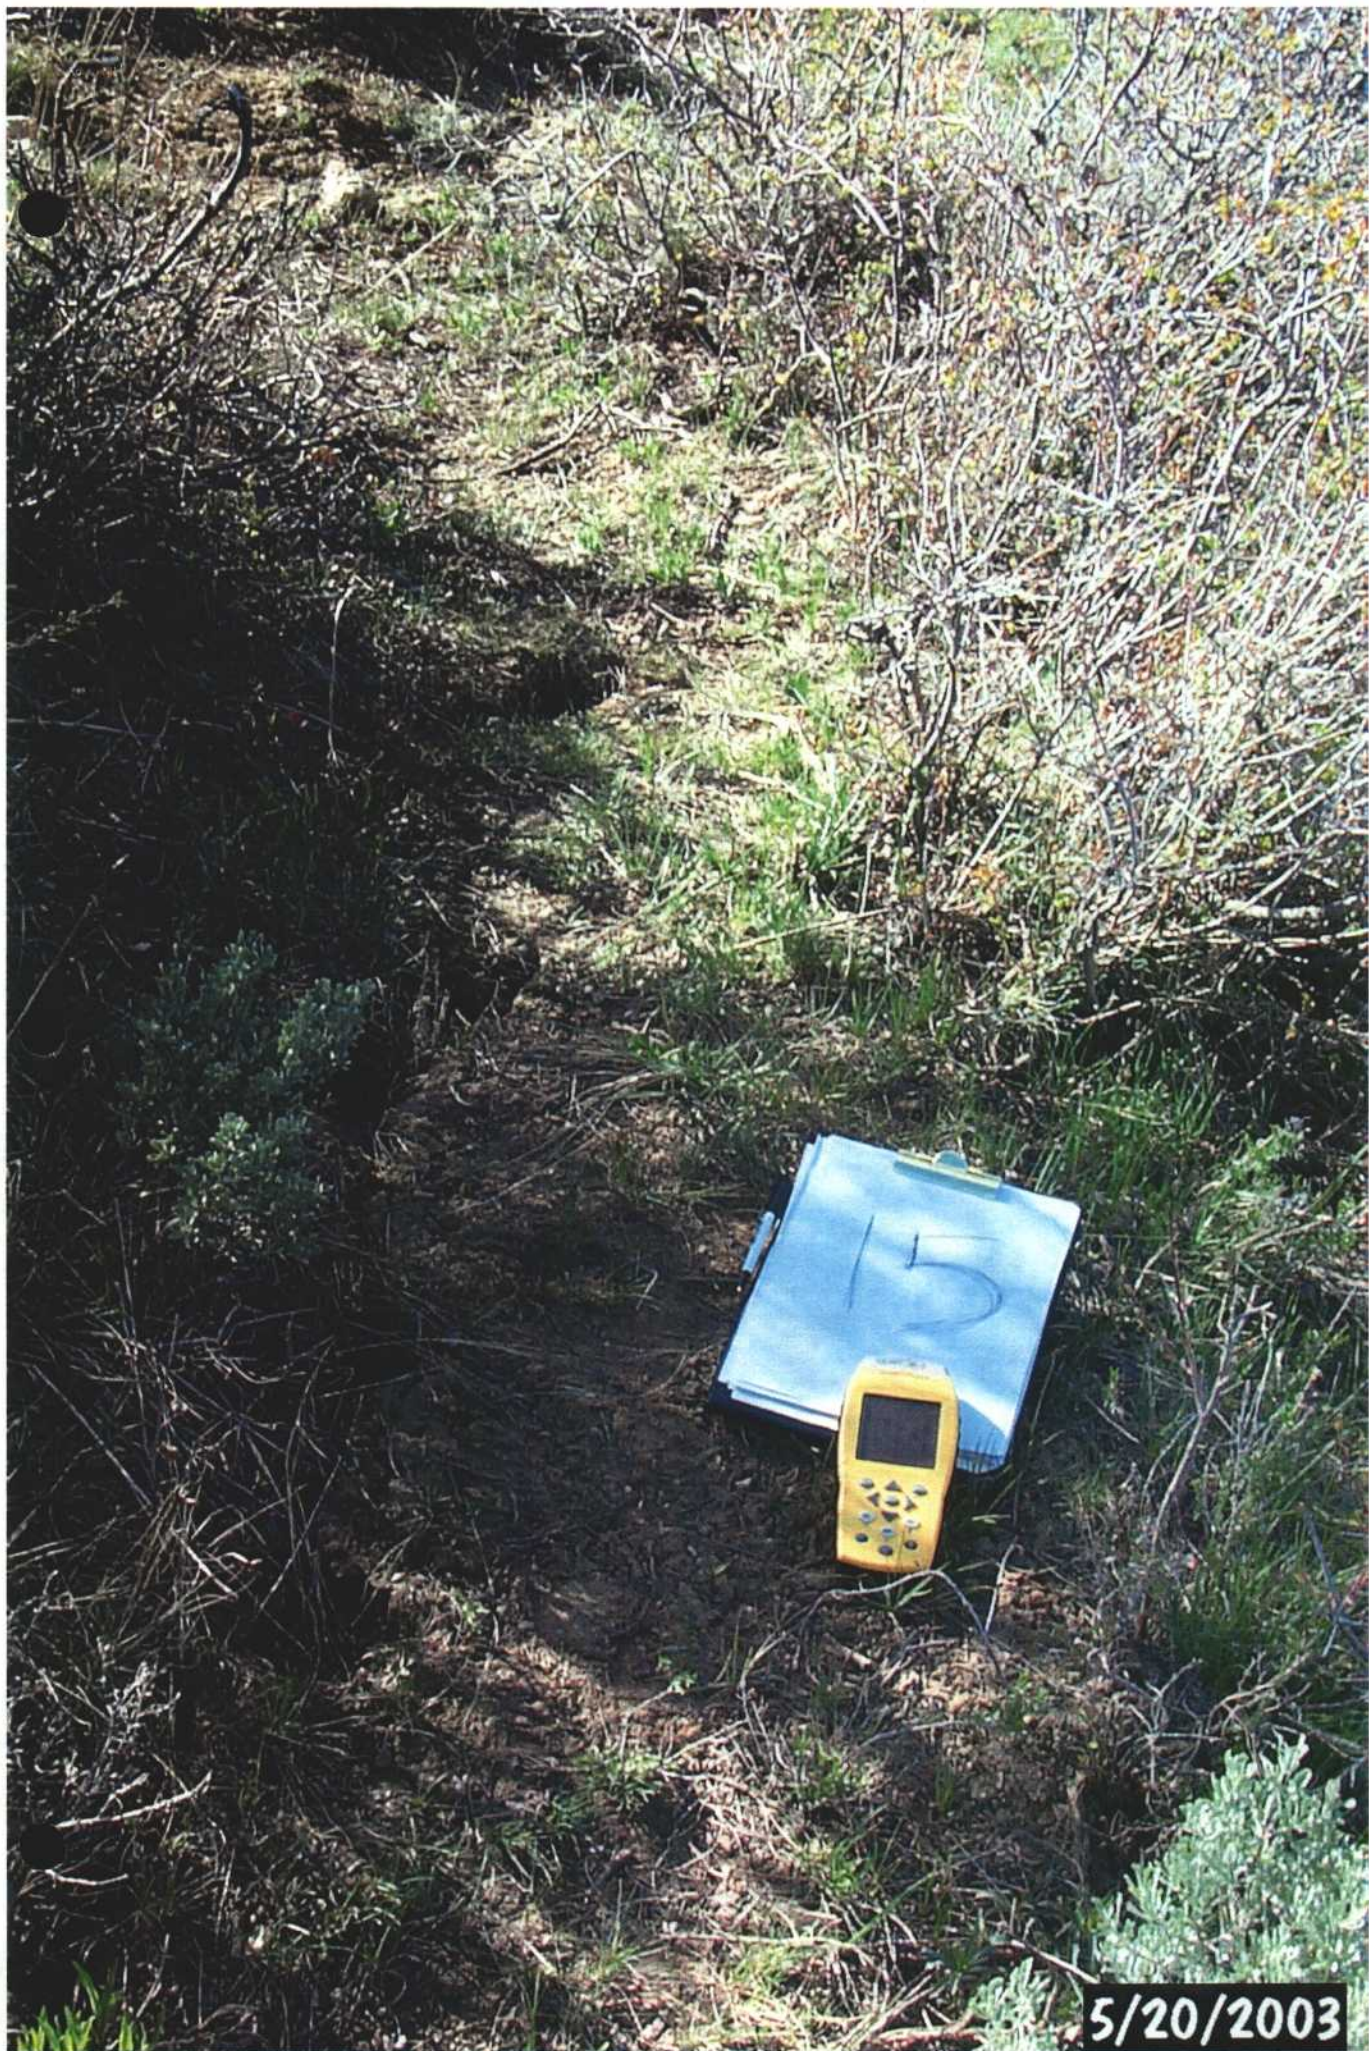
Dimensions (in feet): This crack is 191 feet long, and up to 3 inches wide.

This crack is located on the east flank of the Wildcat Knolls, and appears to be healing well.
